US Army Corps  
of Engineers  
Louisville District

## Partnering to Renovate a Pond Dam

By  
Scot H. Dahms, M.S.  
Supervisory Park Ranger  
U.S. Army Corps of Engineers  
Mississinewa Lake  
Peru, Indiana 46970

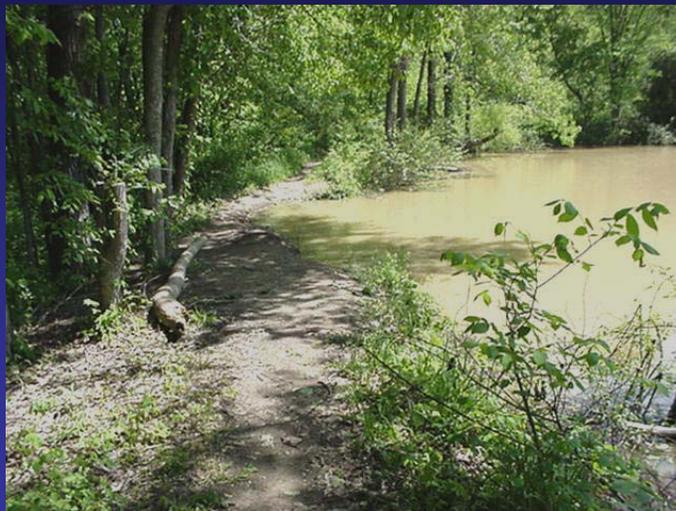
## Dam Overtopping

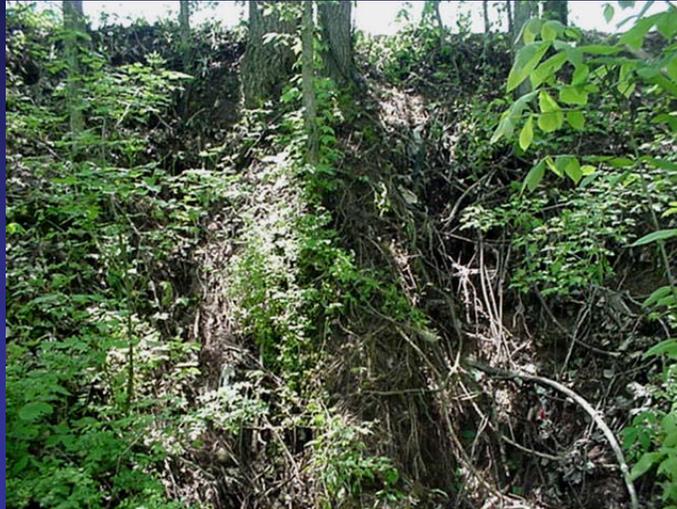
## Erosion

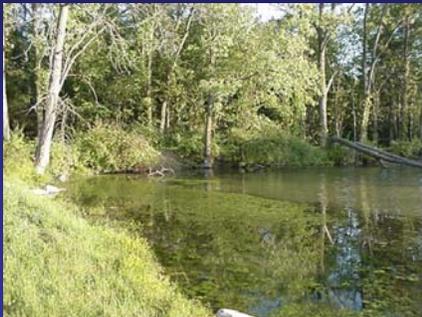
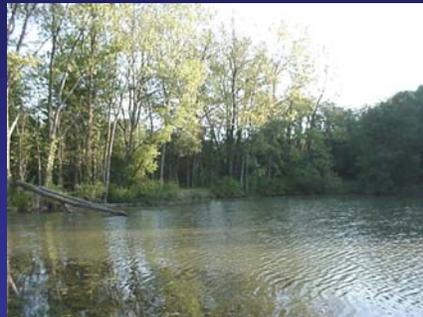
## Woody Vegetation

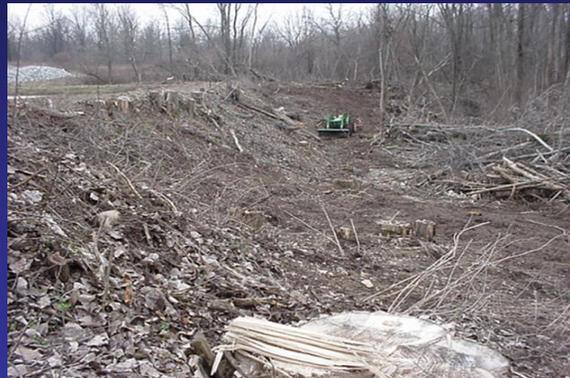
## Downstream Slope

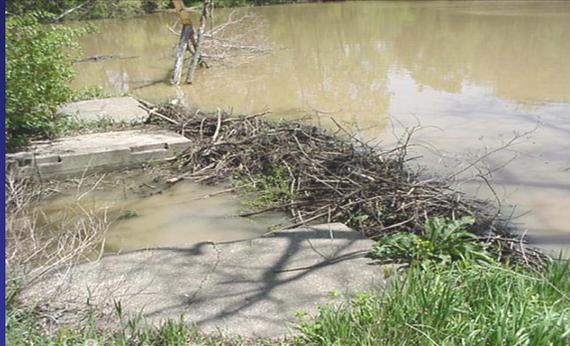
## Beaver Dam

- Piping/settlement - decomposition of roots
- Uneven erosion to spillway - high outflows
- Erosion - toe of dam by channel
- Beavers

- January 2007 – Removed 4 nuisance beaver that clogged spillway
- May 2007 – Regraded spillway because of high outflows and beavers
- July 2007 – Placed more material on downstream slope
- August 2007 – Seeded and placed straw on downstream slope

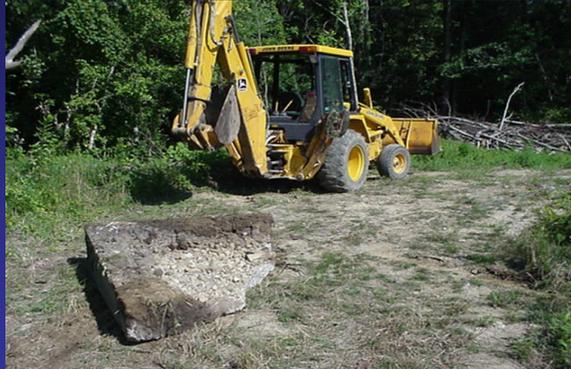
- Min. design storm of 25 year frequency
- 24 hour minimum duration rainfall
- 4.83 inches of precipitation
- Original drainage area – 409 cfs
- Current drainage area – 270 cfs
- Original concrete spillway – 55 cfs

## Concrete Spillway Removed
