Appendix J  
Photos  
Entrance Stations

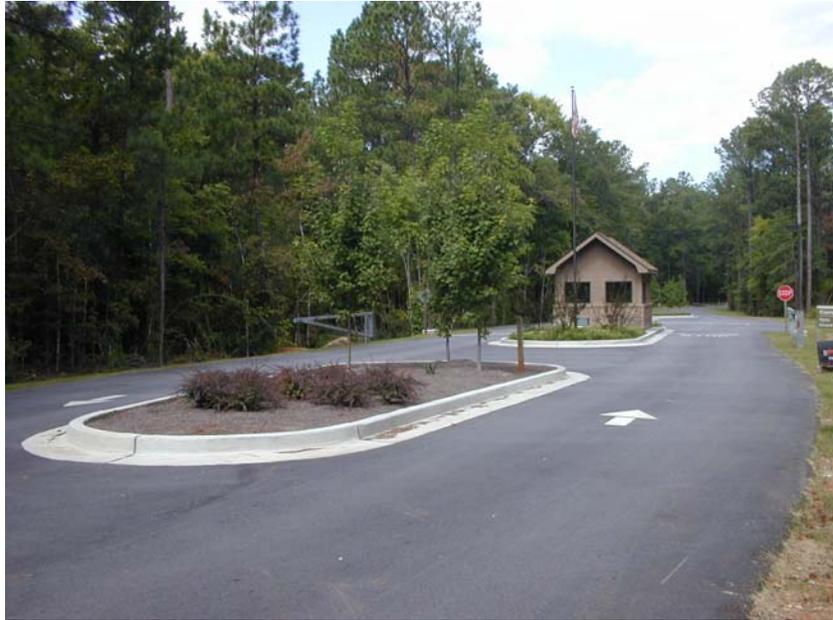
Photo J-1. Entrance station island. Winfield Campground, J. Strom Thurmond Lake, GA. Note recommended center of roadway entrance station location, turnaround incorporated into entrance station approach, and roadway markings to direct traffic flow (Table 3.1)

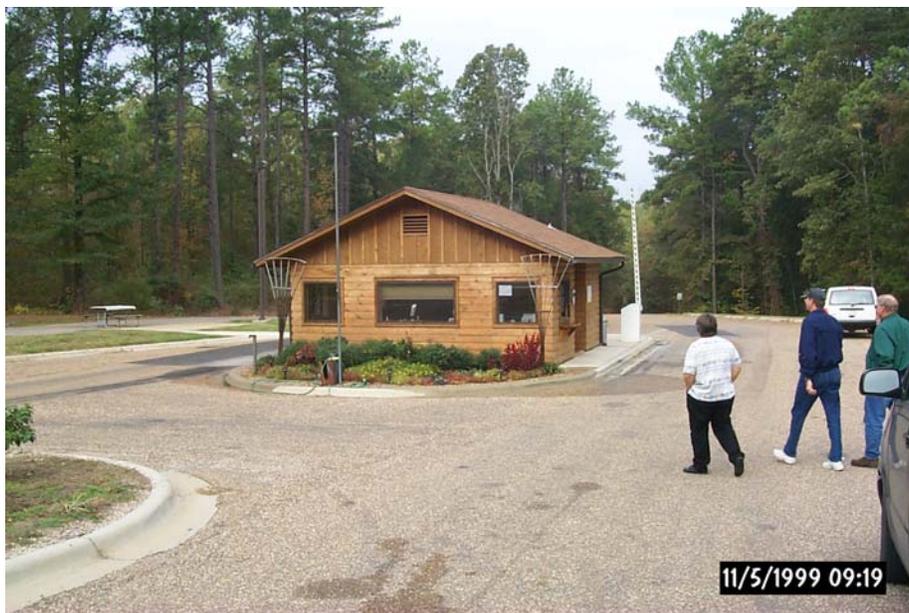
Photo J-2. Entrance station features. Brushy Creek Park, Lake O' the Pines, TX. Note building design and landscaping are in keeping with the theme of the area, and low-maintenance building exterior. Optional dual lanes and recommended turnaround incorporated for customer convenience (Table 3.1)

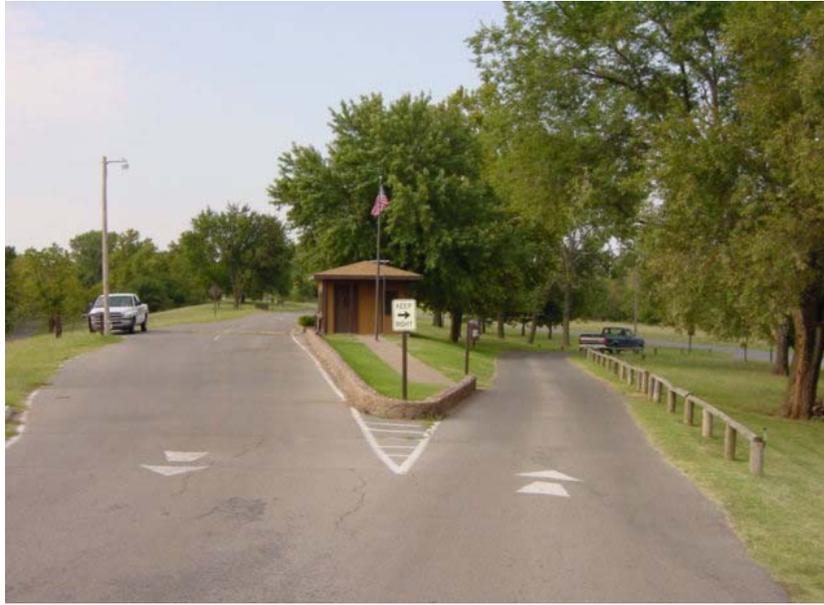
Photo J-3. Dual lanes, Example 1. Canadian Park, Canton Lake, OK. This is the view exiting the park. Note the dual entrance lanes, arrows on pavement designating traffic flow (Table 3.1)

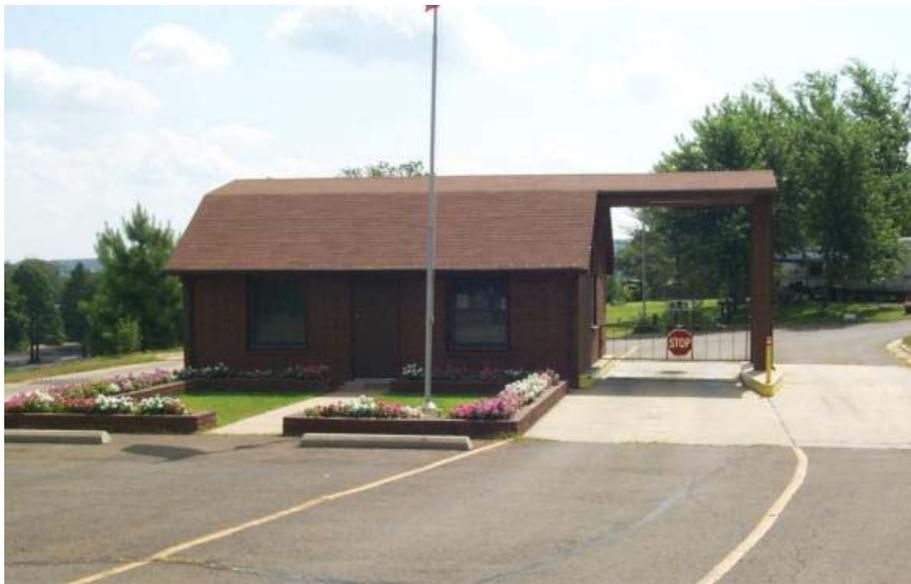
Photo J-4. Dual lanes, Example 2. Taylor Ferry Park, Ft. Gibson Lake, OK. Note dual entrance lanes, traffic control gate, customer parking in front of building so pedestrians do not cross traffic lanes (Table 3.1)

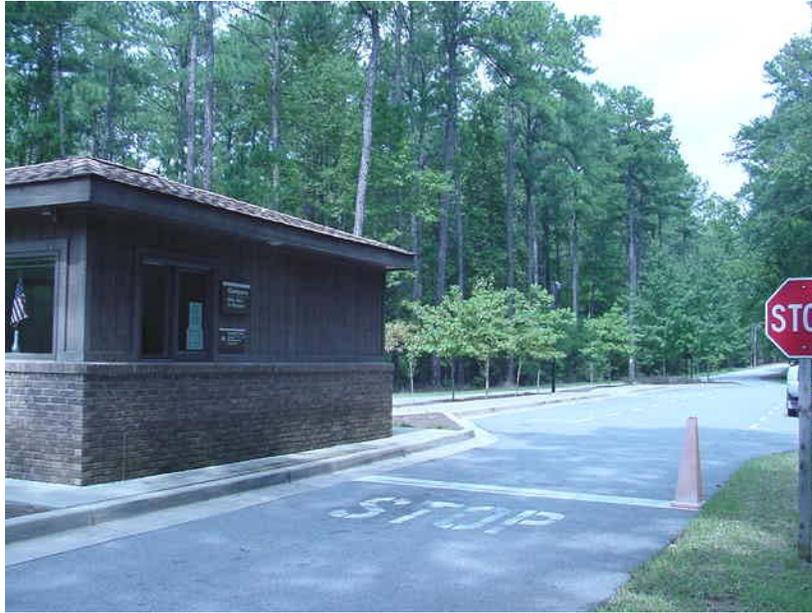
Photo J-5. Customer parking, entrance view. Petersburg Campground, J. Strom Thurmond Lake, SC. Note pullover customer parking area on left so pedestrians do not cross traffic lanes (Table 3.1)

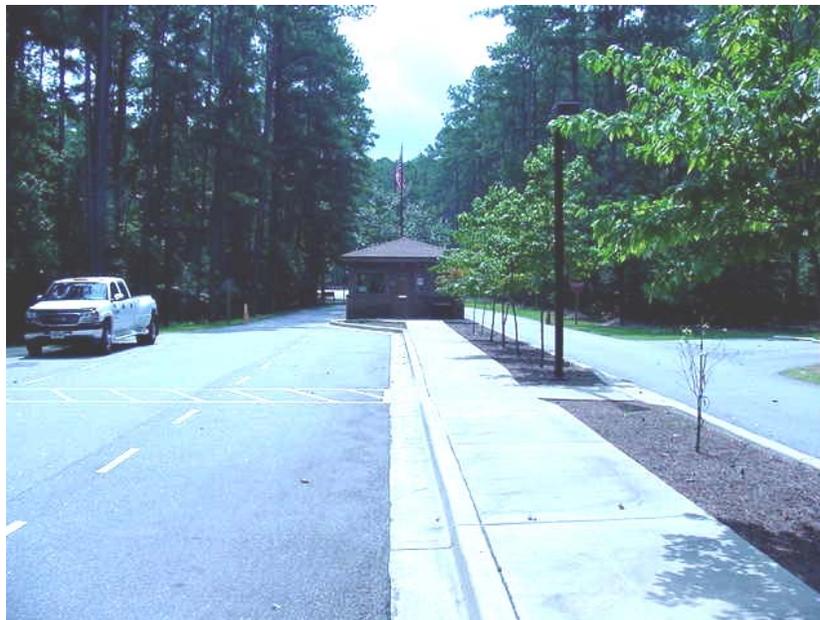
Photo J-6. Customer parking, exit view. Petersburg Campground, J. Strom Thurmond Lake, SC. On left, pullover customer parking on each side of entrance lane for entering customers, and pedestrian crosswalk. On right, head-in parking for exiting customers (Table 3.1)

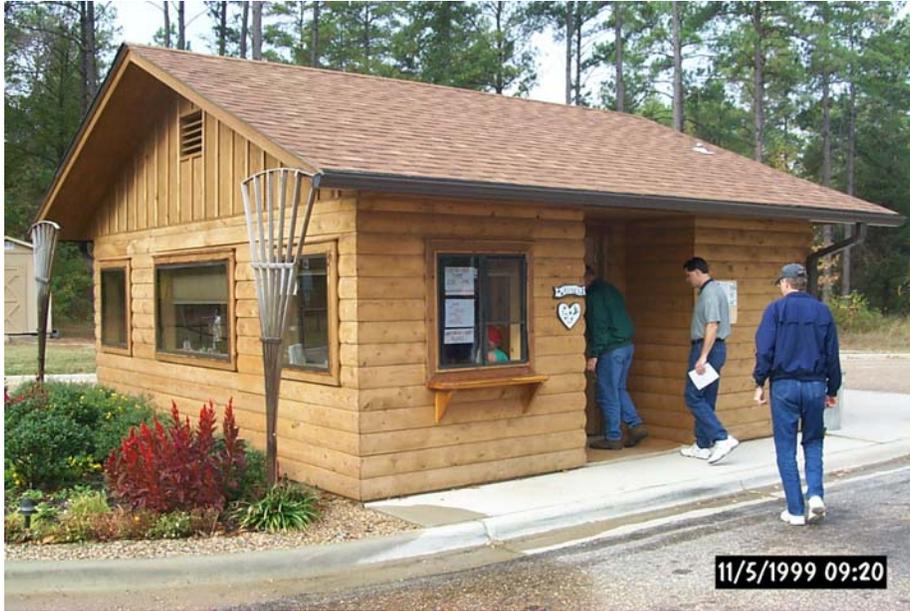
Photo J-7. Customer service window and walk-in area. Brushy Creek Park, Lake O' the Pines, TX. Customers are shown entering walk-in area of entrance station. Note that an outside service window is also provided (Table 3.1)

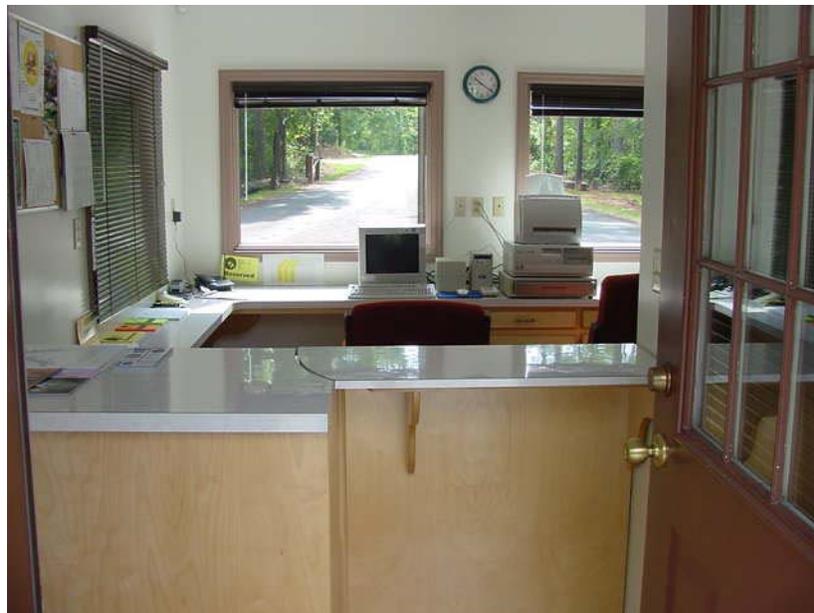
Photo J-8. Customer walk-in area. Modoc Campground, J. Strom Thurmond Lake, SC. Customer walk-in area in entrance station (Table 3.1)

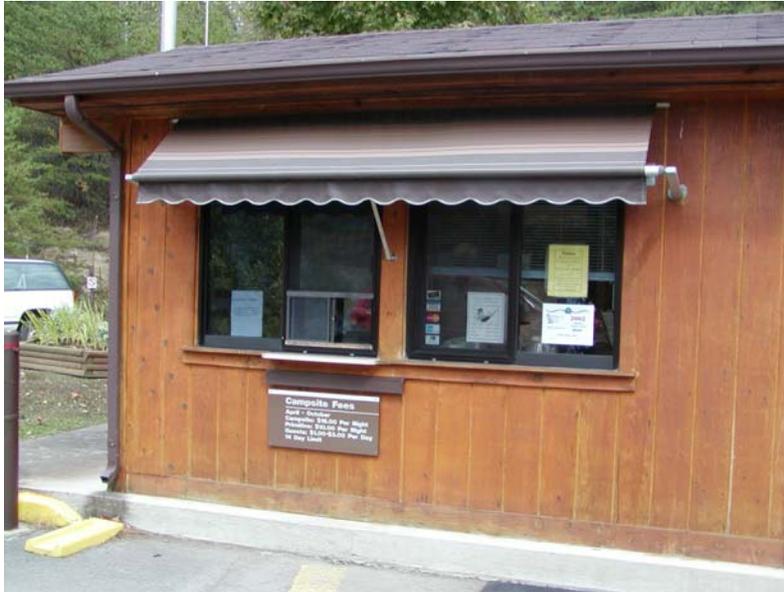
Photo J-9. Customer service window overhang, Example 1. Littcarr Campground, Carr Creek Lake, KY. A retractable RV awning installed to provide customers with protection from the elements while they conduct business at this drive-up outside customer service window (Table 3.1)

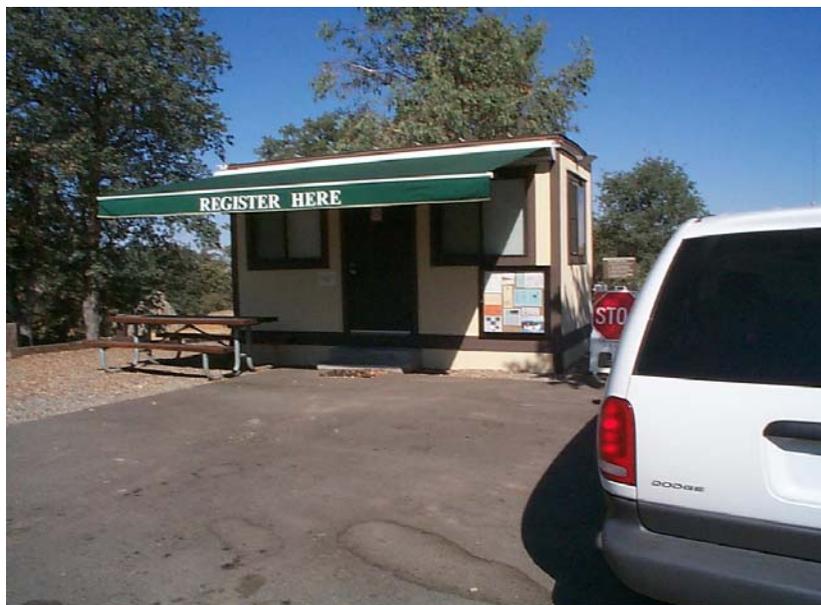
Photo J-10. Customer service window overhang, Example 2. Cordoniz Recreation Area, Eastman Lake, CA. An automated retractable awning is installed at this walk-up outside customer service window (Table 3.1)

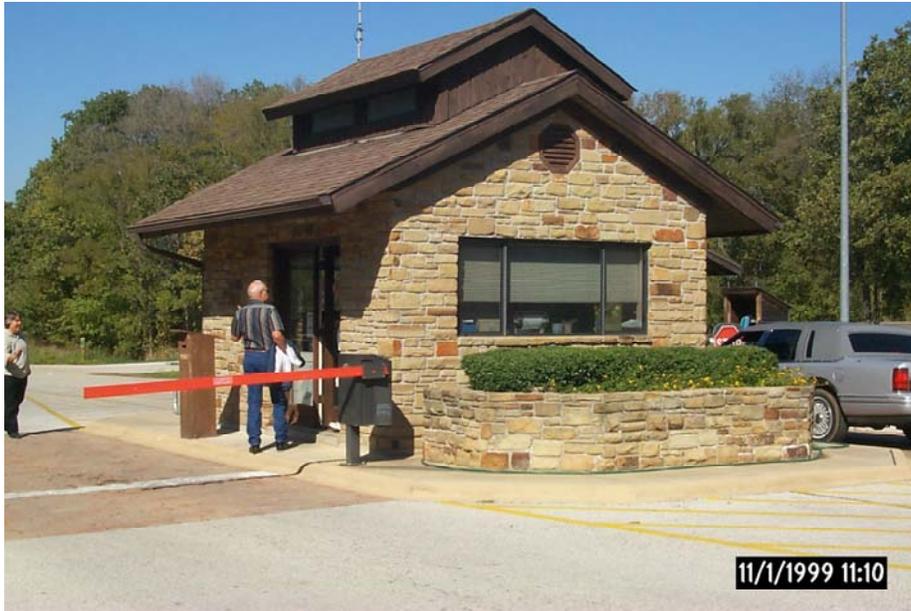
Photo J-11. Automatic gate. Hickory Creek Park, Lewisville Lake, TX. Automatic gate can be operated from inside the entrance station and allows after-hours departures

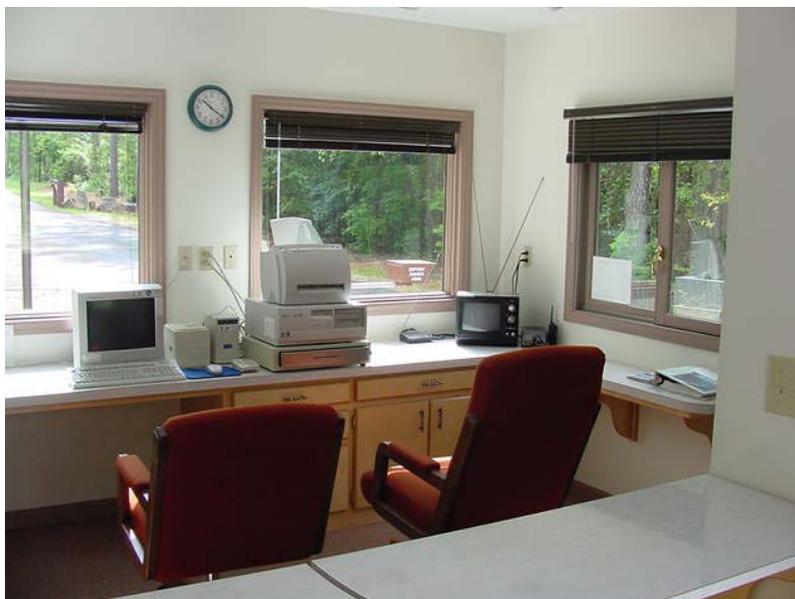
Photo J-12. Interior work area. Ridge Road Campground, J. Strom Thurmond Lake, GA. Interior work area for park attendants sized to accommodate all required equipment (Table 3.1)
