Appendix L

Photos

Fish-Cleaning and Sewage Dump Stations

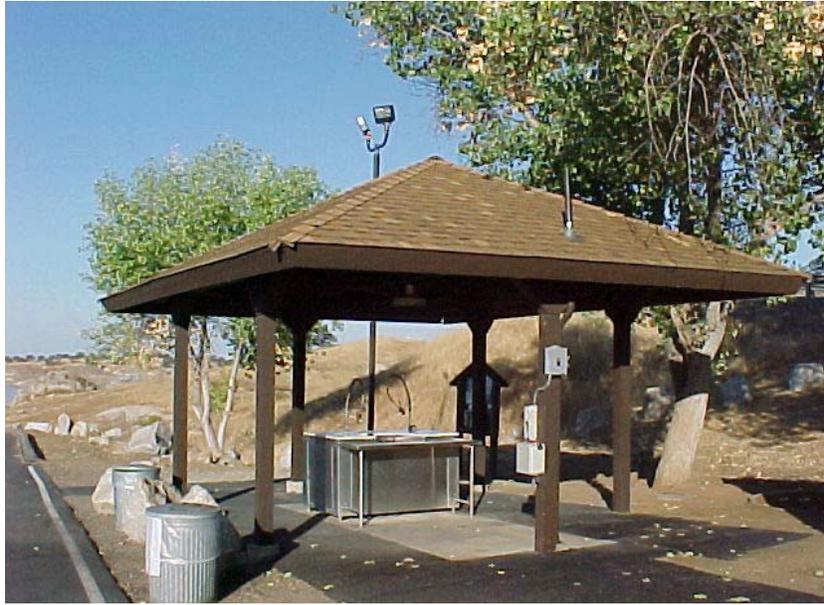
Photo L-1. Fish-cleaning station. Hensley Lake, CA. Note that this fish-cleaning station is shaded and protected from the elements, is UA, is located within 50 ft of parking area, has interior and exterior lighting fixtures, and is isolated from other activities (Table 3.10)

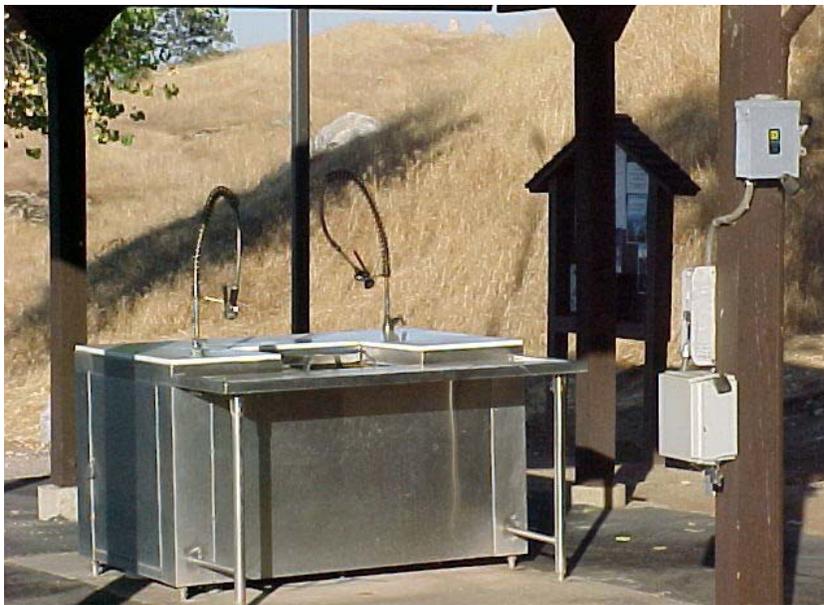
Photo L-2. Interior view of fish-cleaning station. Hensley Lake, CA. Note that this fish-cleaning station has a UA maneuver area, is sited on a concrete pad, and that two water hydrants are provided (Table 3.10). UA utility sink should be a feature of new units

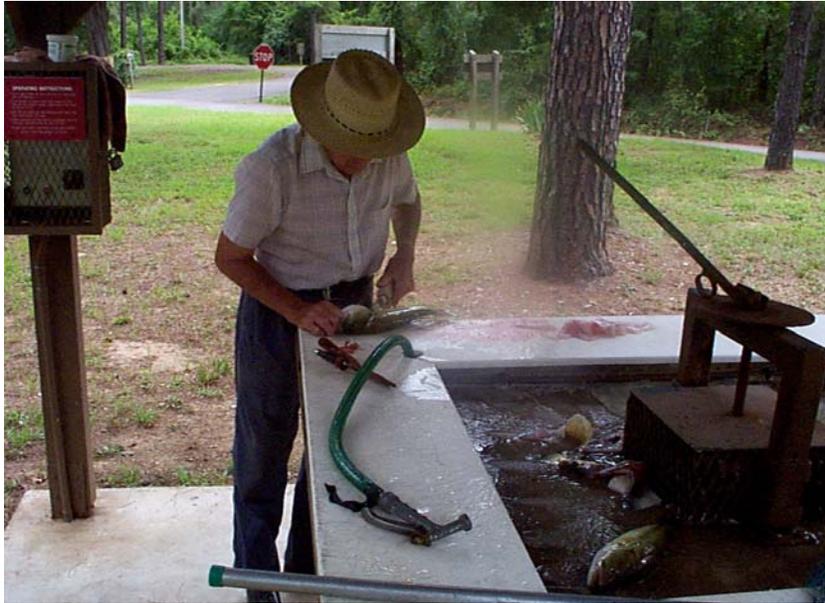
Photo L-3. Customer using fish-cleaning station. Carter Cove Park, Nimrod Lake, AR. This station includes two water hoses with spray nozzles, a 2-hp grinder with timed start/stop switch and custom cover (fish remains go into septic tank and leach field), GFCI receptacles, and night lighting (Table 3.10)

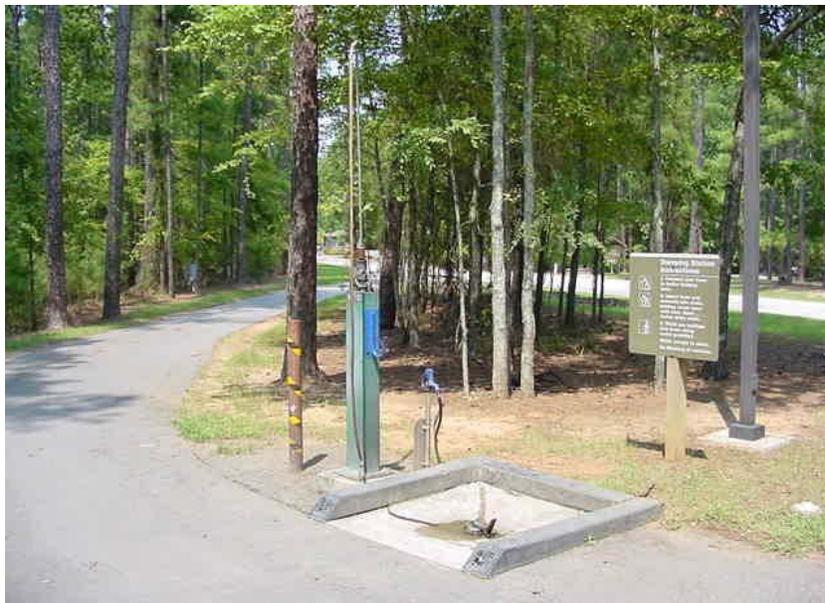
Photo L-4. Sewage dump station. Petersburg Campground, J. Strom Thurmond Lake, GA. This view shows wash down and signage. The potable water spigot is outside of photo (Table 3.11)

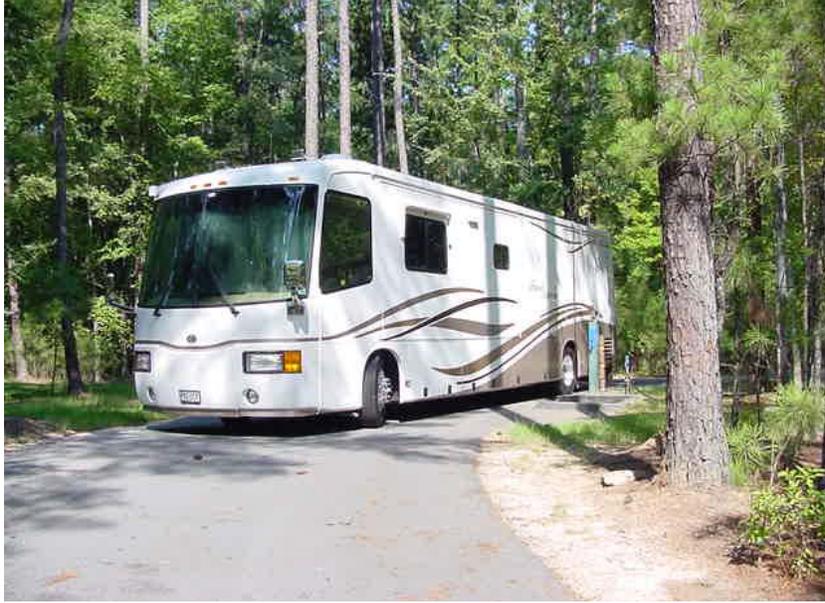
Photo L-5. RV customer using sewage dump station. Note that drain and water are on driver side of RV (Table 3.11)
