US Army Corps  
of Engineers  
Louisville District

## Partnering to Renovate a Pond Dam

By  
Scot H. Dahms, M.S.  
Supervisory Park Ranger  
U.S. Army Corps of Engineers  
Mississinewa Lake  
Peru, Indiana 46970

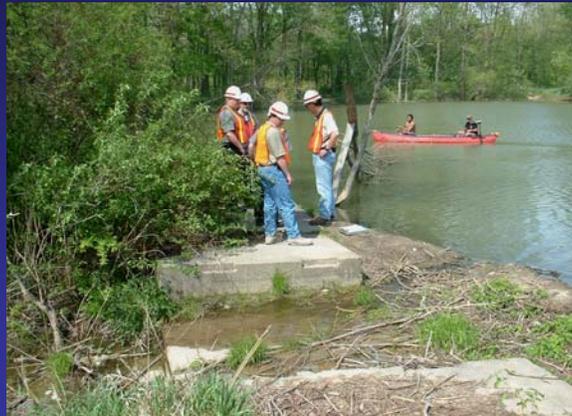
## 2004 Periodic Inspection

- Woody vegetation
- Steep slopes
- Inadequate spillway system
- Large drainage area

- Inadequate erosion protection
- Reduced storage capacity
- No drawdown device or drain valve
- Beavers

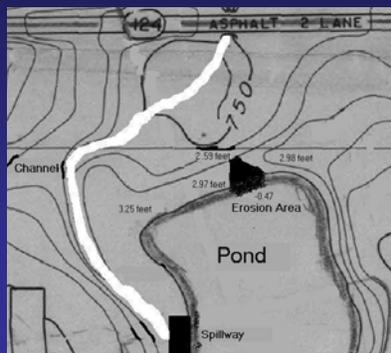
## Dam Dimensions and Design

- 247 feet long
- East – west
- Height – 15 feet
- Freeboard – 3 feet
- Erosion area

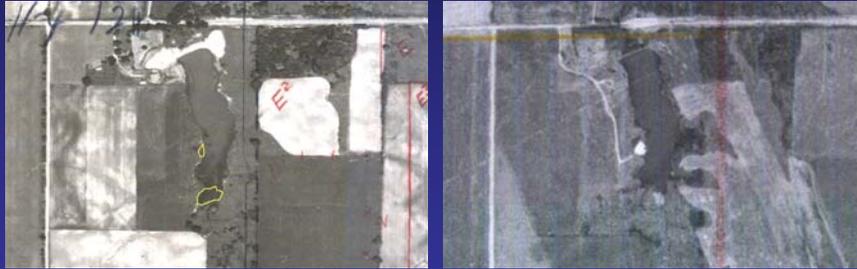
## Pond – 1957 and 1971

- Water storage lost – 8.8 acre-feet
- Original maximum depth – 12 feet
- Current maximum depth – 7 feet
- Pond elevation lowered 1 foot from 8 feet during renovation

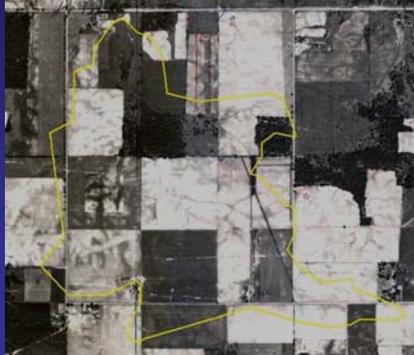
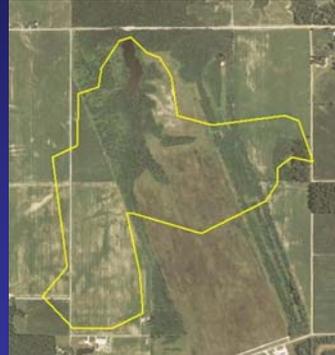
## Original and Current Drainage Areas

- Variables produce a range of sizes
- Precip., soils, cover/land use, pond size
- Indiana recommended sizes
  - Original 4.65 acre pond – 28 to 116 acres
    - 413 acres – 4 times too large
  - Current 4.31 acre pond – 26 to 108 acres
    - 234 acres – 2 times too large

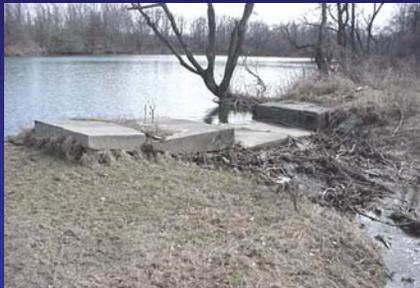
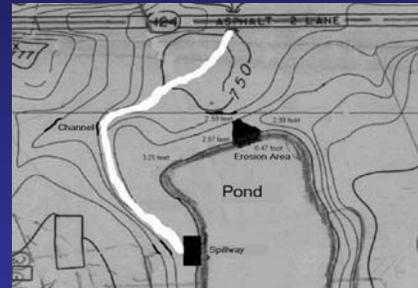
# Concrete Spillway

- Min. design storm of 25 year frequency
- 24 hour minimum duration rainfall
- 4.83 inches of precipitation
- Original drainage area – 409 cfs
- Current drainage area – 270 cfs
- Original concrete spillway – 55 cfs

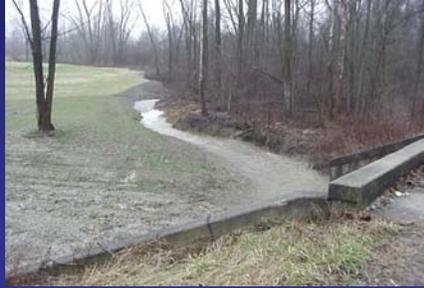
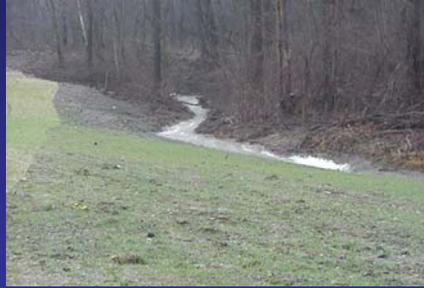
## Spillway Channel Under Flow

- Piping/settlement - decomposition of roots
- Uneven erosion to spillway - high outflows
- Erosion - toe of dam by channel
- Beavers
