Appendix M
Photos
Campgrounds

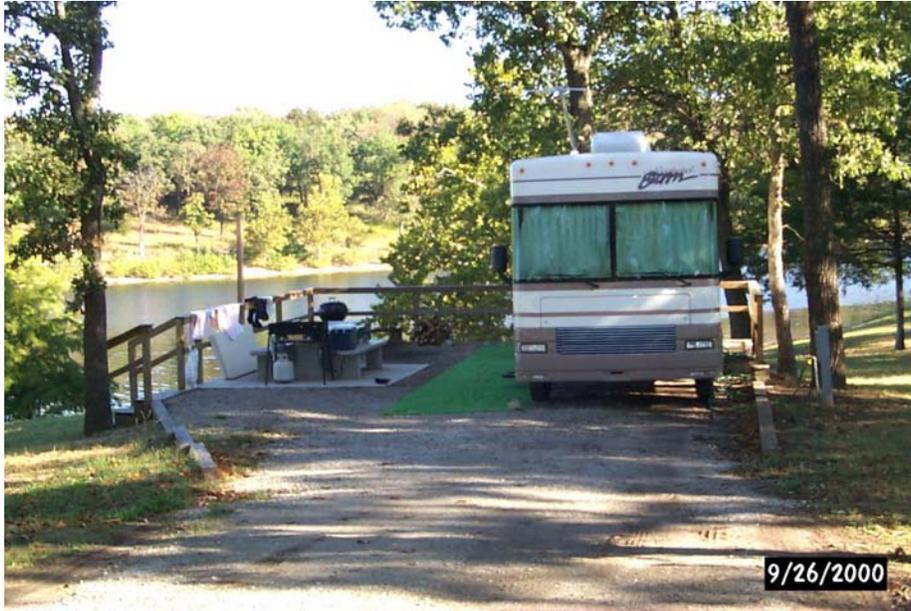
Photo M-1. Shaded and water-oriented campsite. Pomme de Terre Lake, MO. This campsite satisfies customer preferences for shade and proximity to the lake or river (Table 5.1 and Para. 5.3)

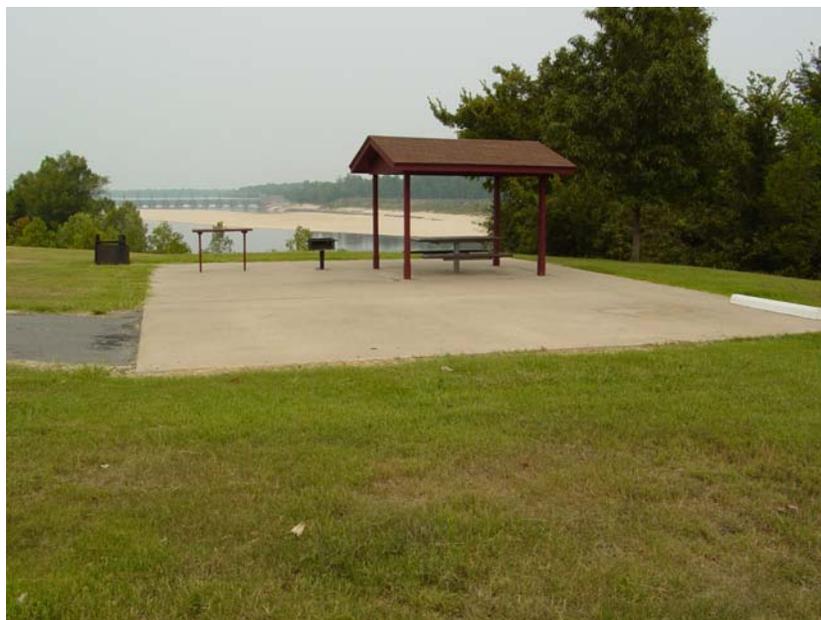
Photo M-2. Shaded UA campsite. Wilbur D. Mills Park, Pine Bluff Project, AR. This campsite is UA (Para. 5.2.1) and has a shelter to provide shade since existing vegetation is not available (Table 5.1)

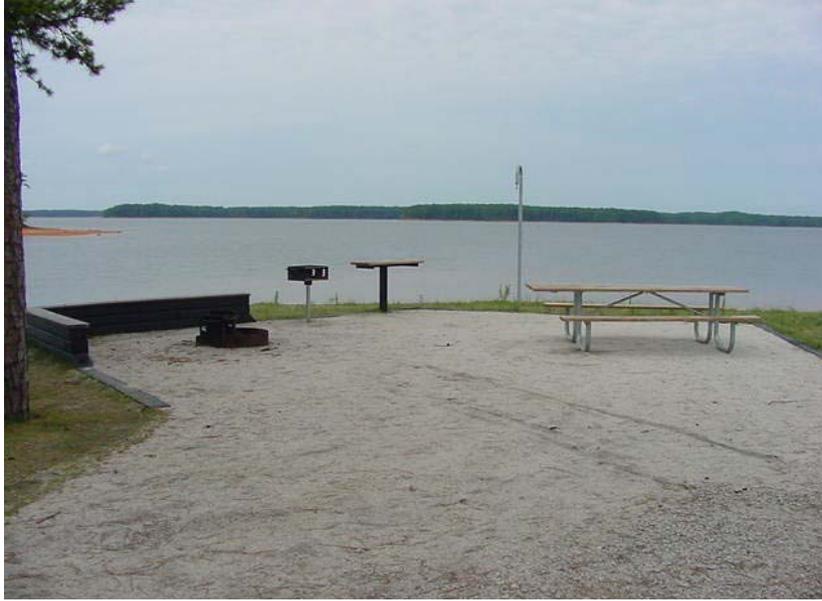
Photo M-3. Campsite amenities. Modoc Campground, J. Strom Thurmond Lake, SC. View of typical campsite amenities, to include utility table, fire ring/grill, pedestal grill, lantern hanger, and UA picnic table (Table 5.2)

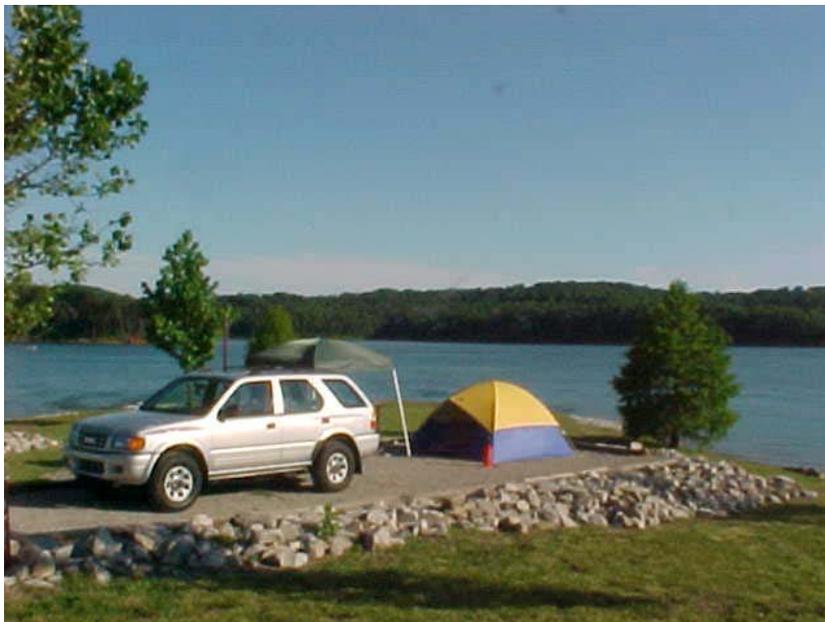
Photo M-4. Hardened living area. Moutardier Campground, Nolin River Lake, KY. Fine crushed stone surface provided (Para. 5.3.3.1)

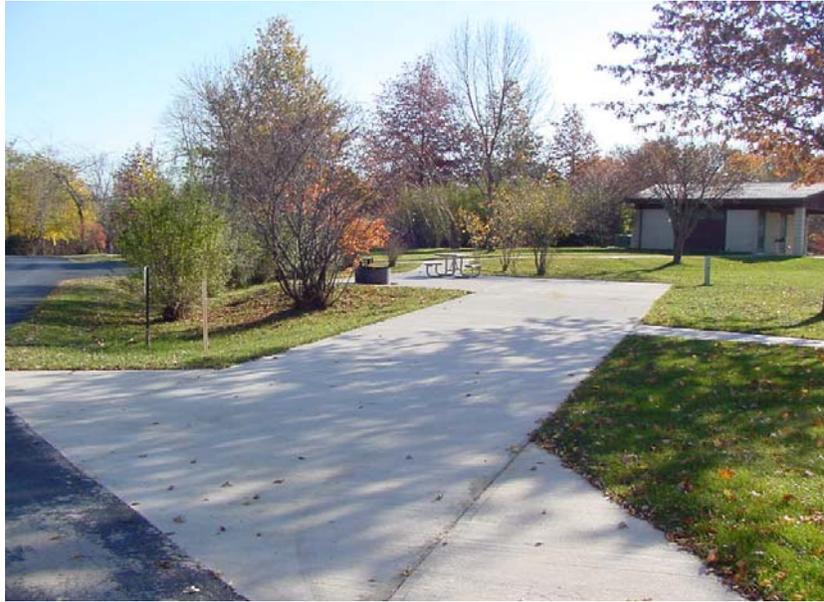
Photo M-5. Designated UA site, Example 1. Acorn Valley Campground, Saylorville Lake, IA. Fully concreted campsite (Para. 5.3.1)

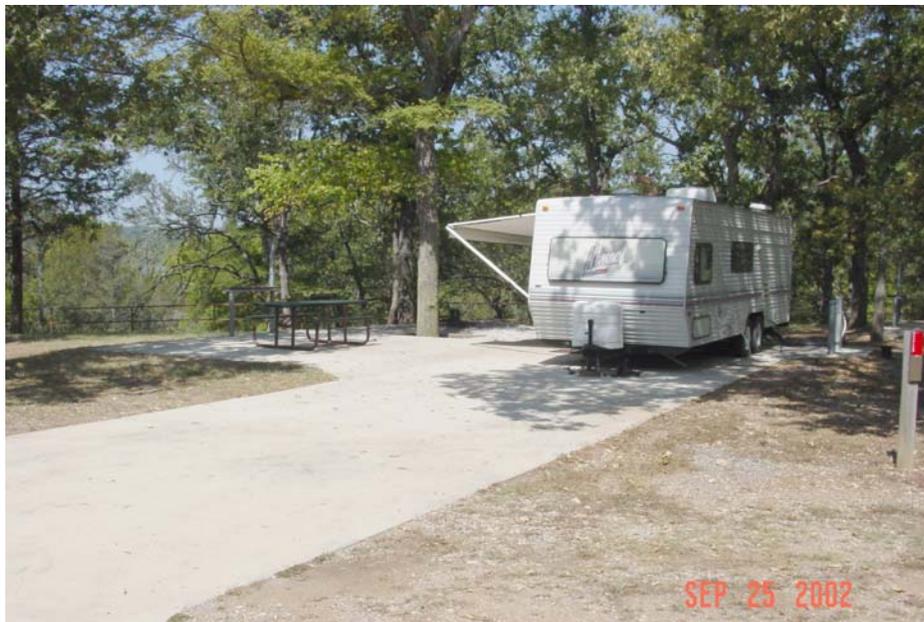
Photo M-6. Designated UA site, Example 2. Pettit Bay Recreation Area, Tenkiller Ferry Lake, OK. Fully concreted campsite (Para. 5.3.1)

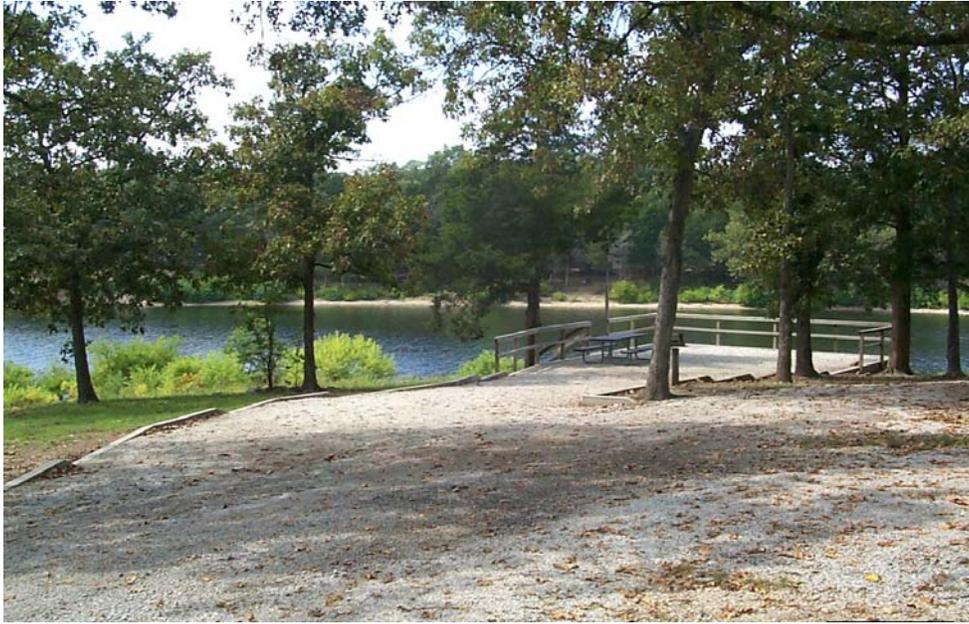
Photo M-7. Camping spur follows terrain - Example 1. Pomme de Terre Lake, MO. (Table 5.1). This photo also demonstrates hardened living area located on the passenger side, timber border, provision of room for RV slideouts, and required site amenities (Table 5.4)

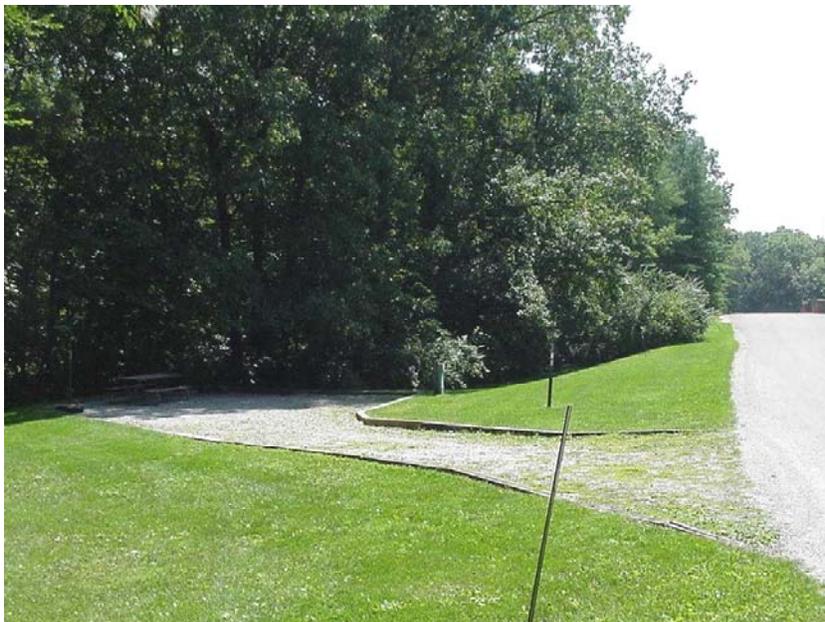
Photo M-8. Camping spur follows terrain - Example 2. Note how cut and fill are avoided by building this back-in site on the contour (Table 5.1)

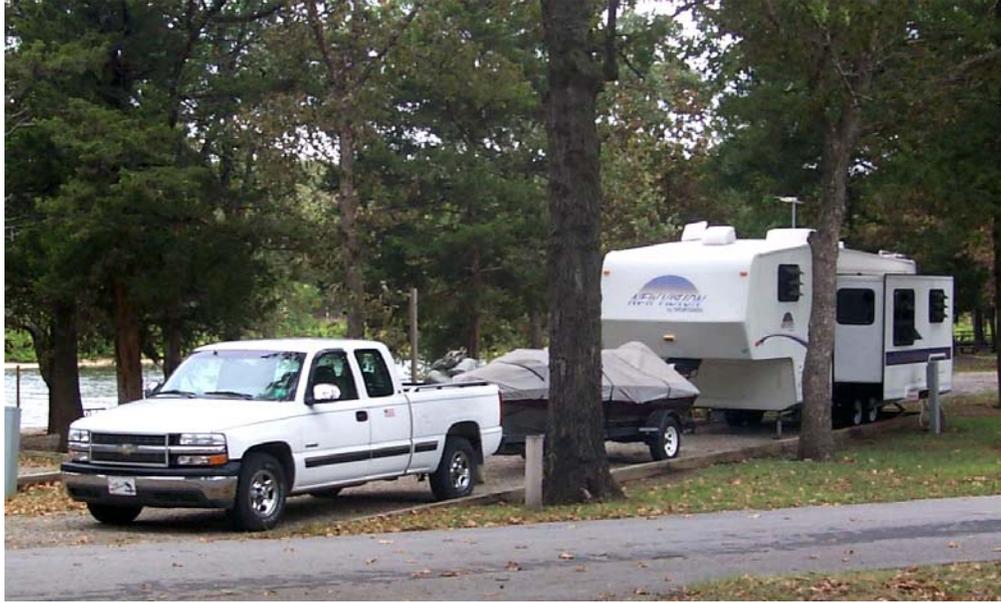
Photo M-9. Back-in site - multiple vehicles. Pomme de Terre Lake, MO. This photo demonstrates 70-ft spur length that provides additional parking space to accommodate car and boat trailer along with RV. Site provides room for RV slideouts (Tables 5.2 and 5.3)

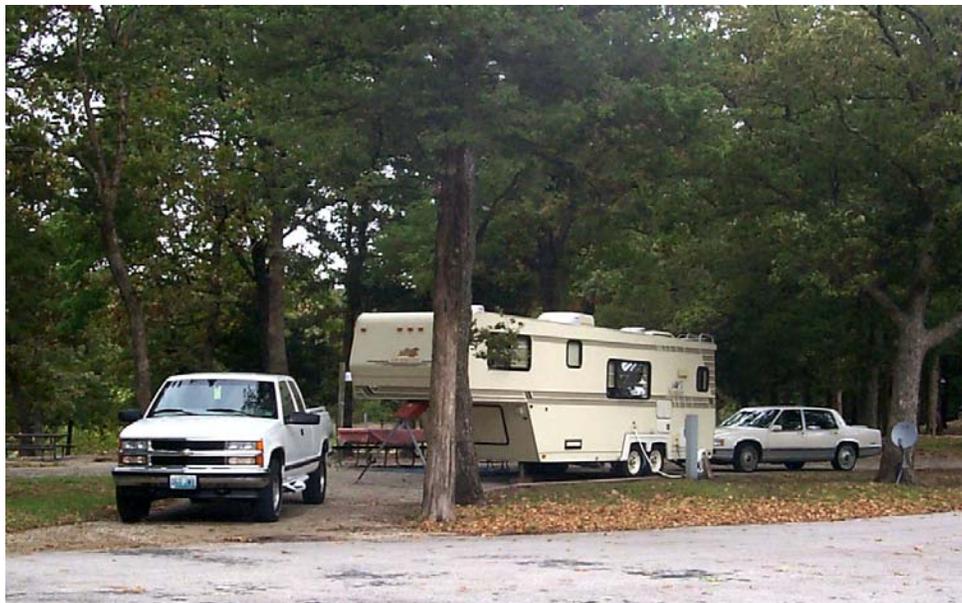
Photo M-10. Pull-through site - multiple vehicles. Pomme de Terre Lake, MO. This shaded campsite demonstrates 70-ft parking area length with room for extra vehicle, level and hardened parking area, and individual utility hookups (Tables 5.2 and 5.3)

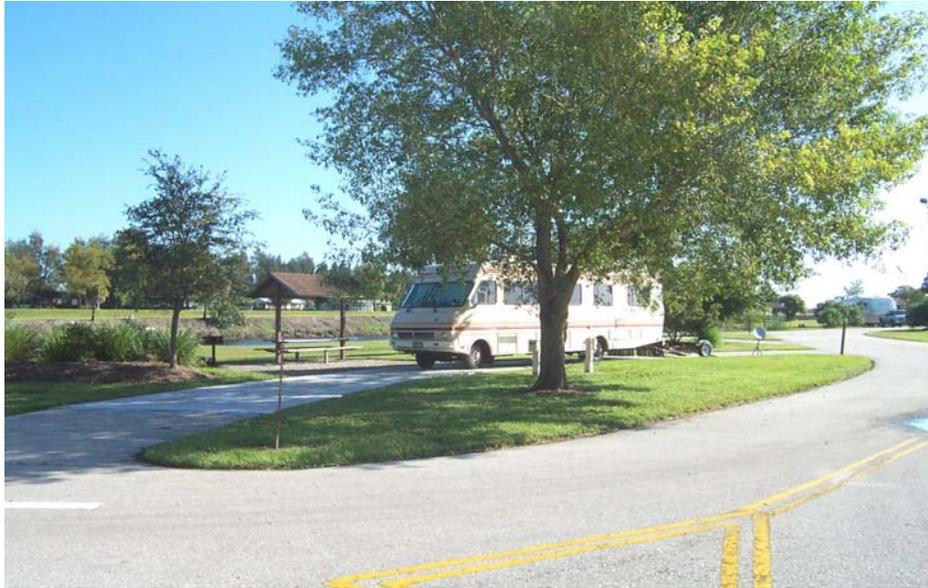
Photo M-11. Pull-through site - double. Ortona South Campground, Lake Okeechobee Waterway, FL. Note landscape plantings for buffer and aesthetics are indigeneous, low-maintenance, sustainable. Shade provided by combination of trees and shelter (Table 5.1)

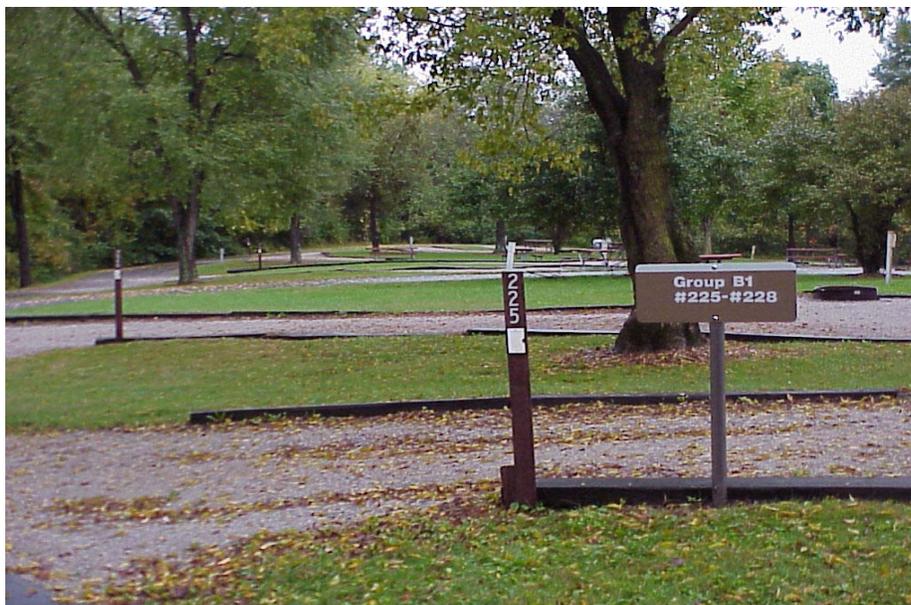
Photo M-12. Group camping area. Sugar Bottom Group Camping Area, Coralville Lake, IA. Where feasible, group campsites may be provided within a campground or in close proximity to an existing campground (Para. 5.3.1.1)

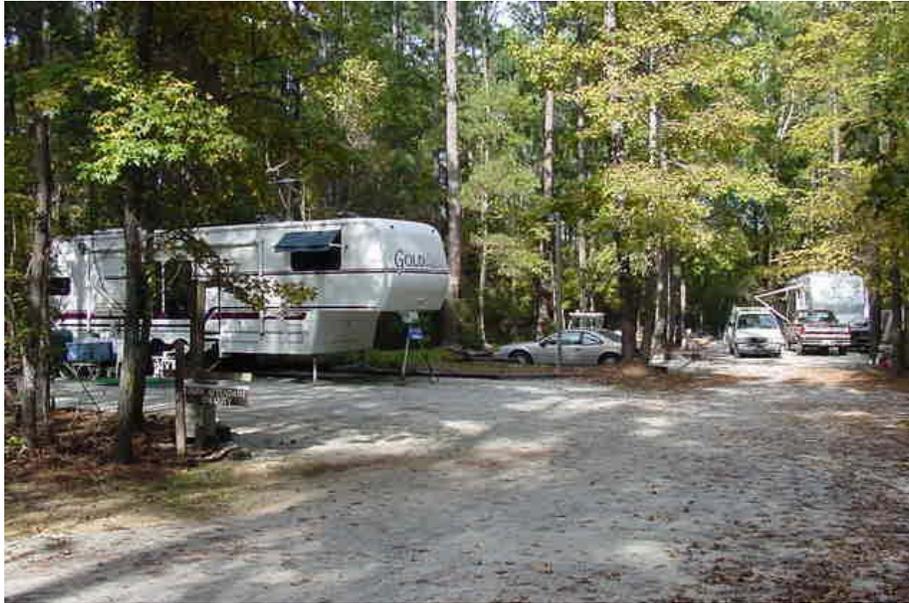
Photo M-13. Park attendant campsite. Petersburg Campground, J. Strom Thurmond Lake, GA. Located near the campground entrance, inside the gates. Vegetation screens living area for privacy. Sign helps campers easily locate attendants in the event of an emergency (Para. 5.3.1.2, Table 5.2)

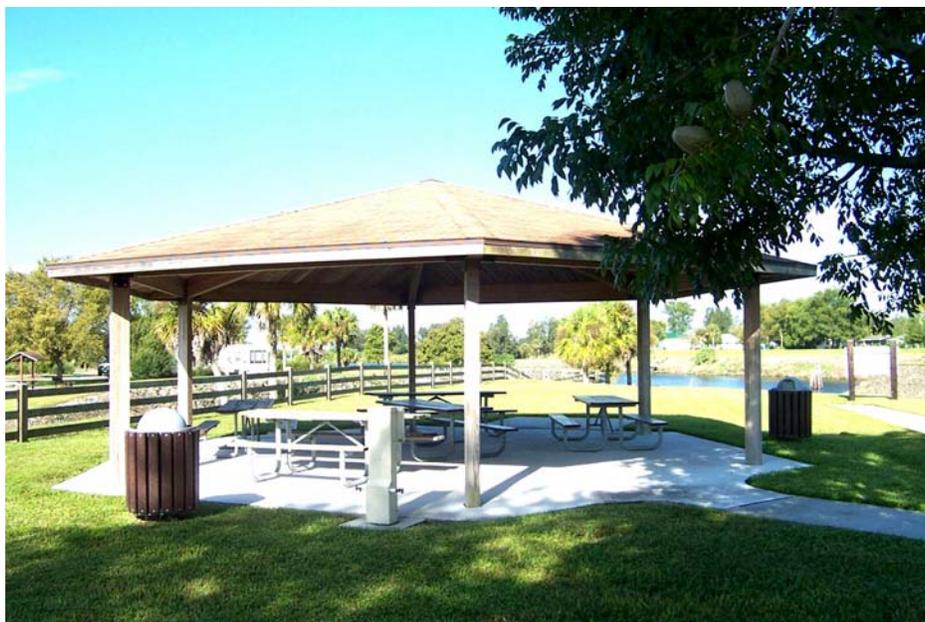
Photo M-14. Group shelter in campground. Ortona South Campground, Lake Okeechobee Waterway, FL. This communal gathering point for campers was constructed after a local Customer Care Survey indicated local demand (Table 5.2, Para. 6.3)

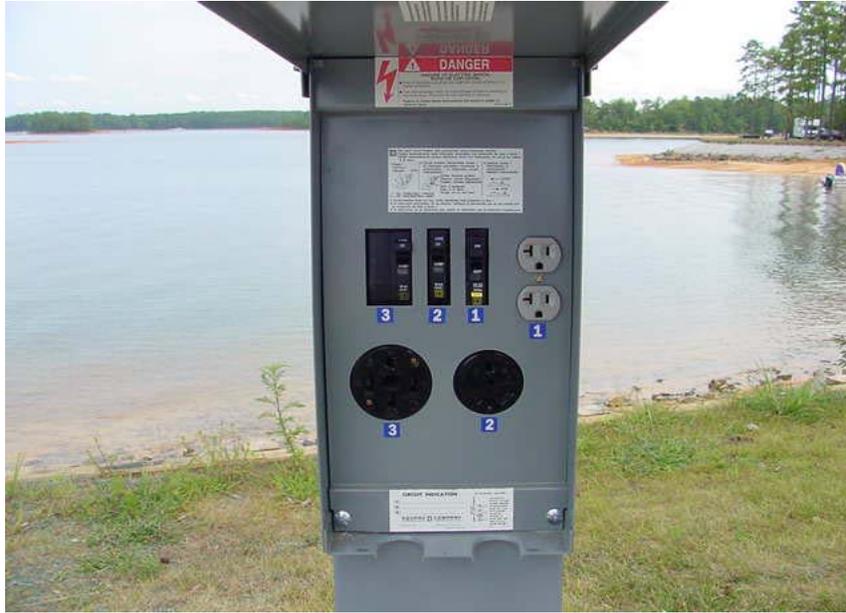
Photo M-15. Electrical Pedestal. Pedestal with 50-, 30-, and 20-amp (GFCI) hookups (Table 5.5)

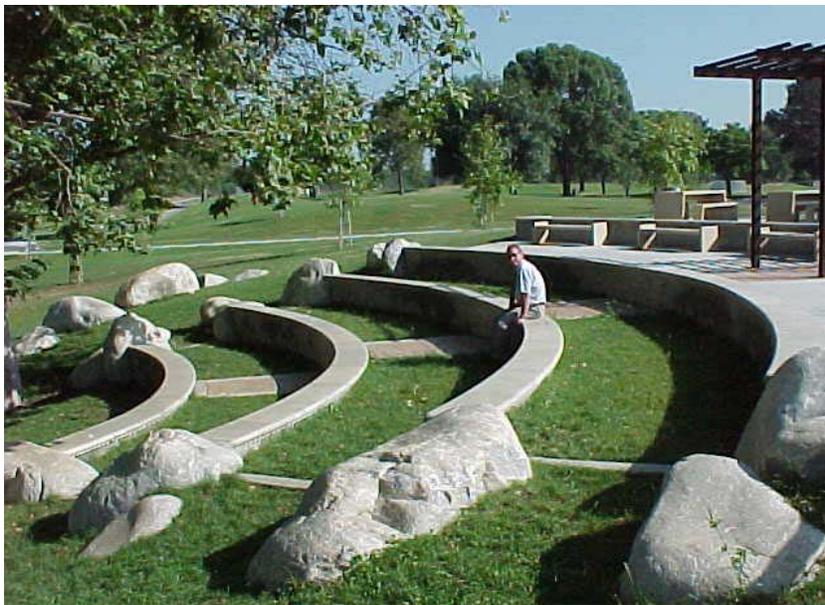
Photo M-16. Low-maintenance amphitheater. City of Los Angeles outgrant, Lake Balboa, Los Angeles District. Amphitheater is constructed of low-maintenance materials that are indigenous to the site. This is an example of a sustainable design. Note that top section is UA (Para. 5.4.8.1)
