Appendix O

Photos

Swim Areas

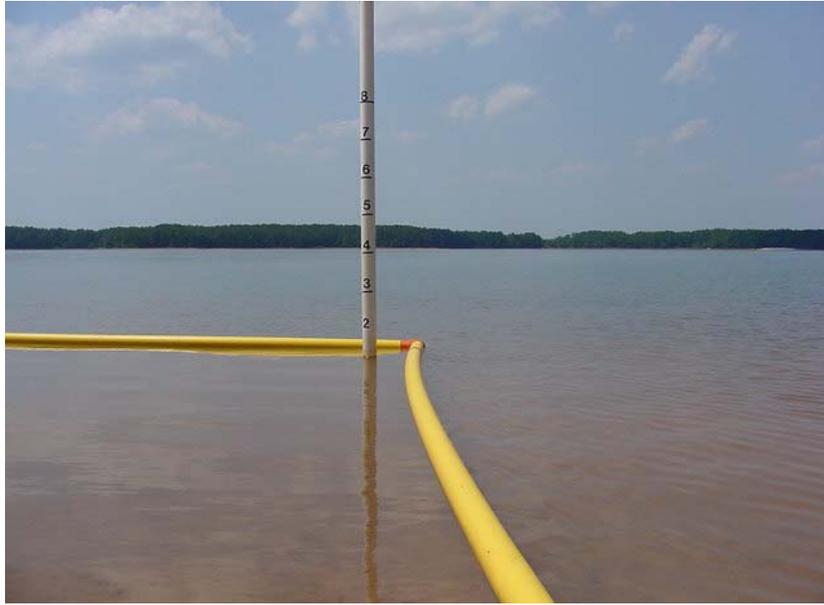
Photo O-1. Beach delineation and depth marker. J. Strom Thurmond Lake. The required swim area limit delineation is accomplished using floating pipeline. Note the required depth marker delineating each 1-ft change in water depth (Table 5.11)

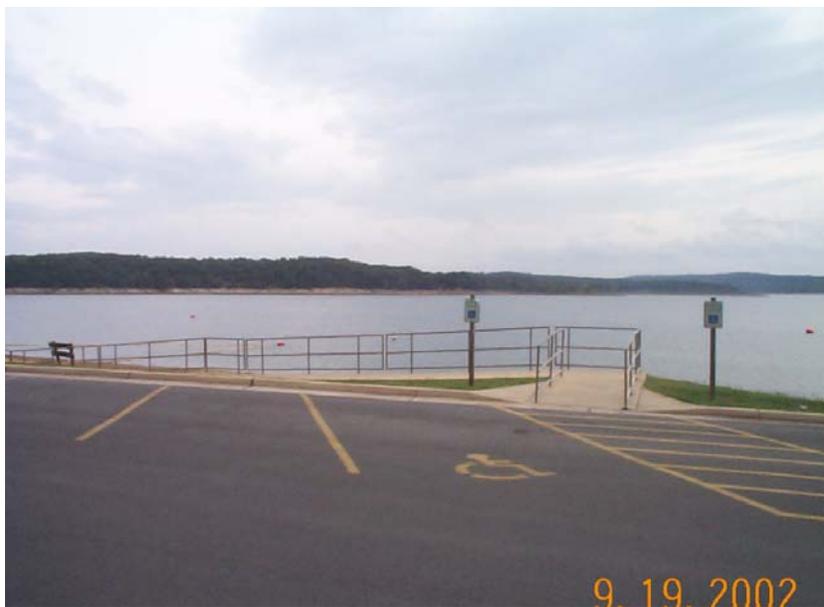
Photo O-2. UA ramp to swimming area. Cranfield Park, Norfolk Lake, AR. A concrete ramp from the parking lot to the swimming area enables wheelchair users to access the water (Para. 5.2.1)
