Appendix P
Photos
Picnic Facilities

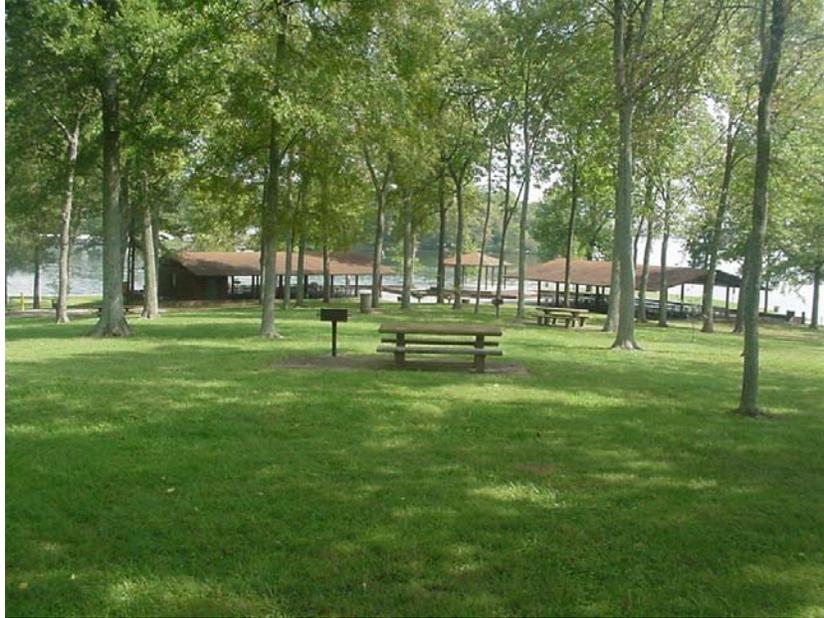
Photo P-1. Plaza approach for picnic shelter placement. Rockland Recreation Area, Old Hickory Lake, TN. This example of a plaza approach combines multiple shelters and related amenities to serve large groups and extended family gatherings (Para. 3.4)

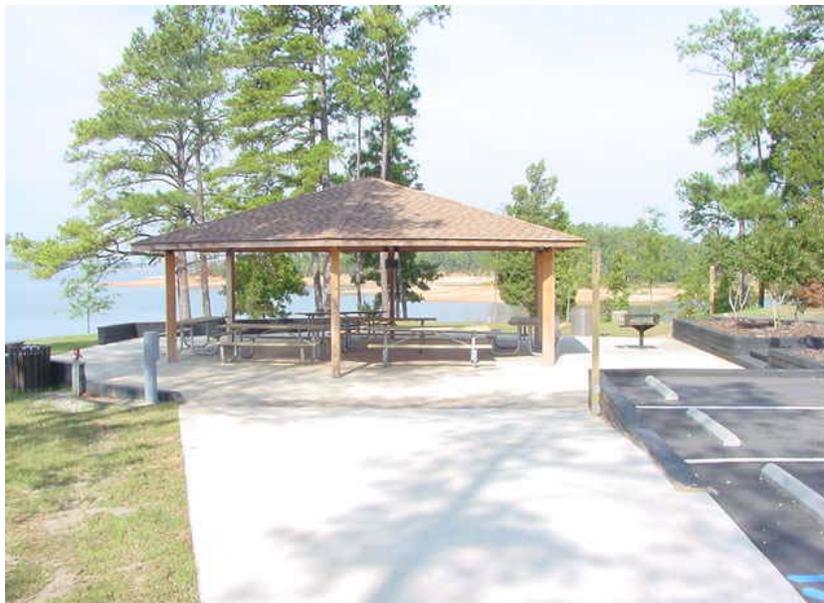
Photo P-2. Picnic shelter concrete pad. Clarks Hill Park, Hannah Point Shelter, J. Strom Thurmond Lake, SC. Note that concrete pad extends beyond the edge of the support posts for UA, and is sloped to drain away from the shelter (Table 3.2)

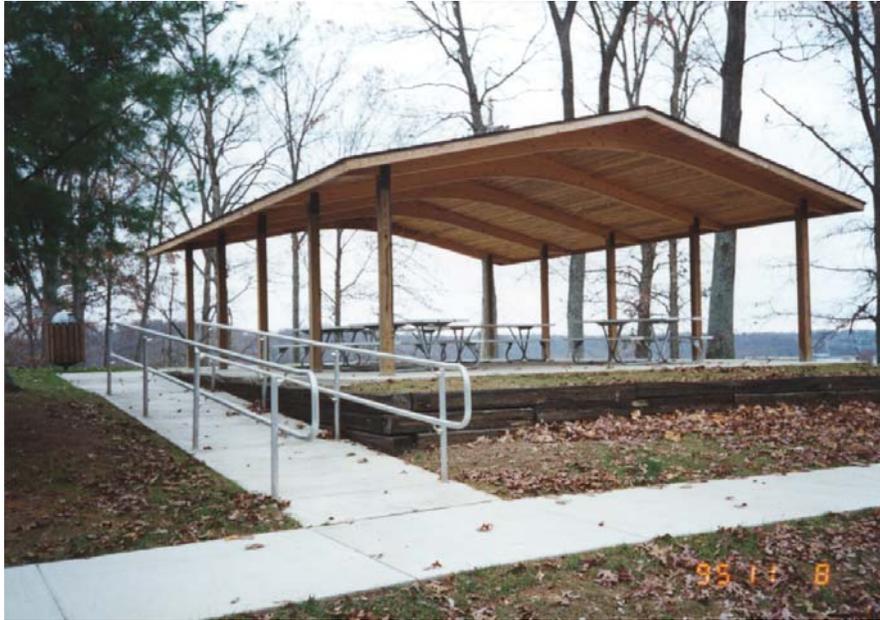
Photo P-3. Picnic shelter roof trusses. Overlook Area, Monroe Lake, IN. Note that roof trusses do not allow birds to roost or build nests (Table 3.2). This shelter constructed from a prefab kit. Also note railings incorporated on sidewalk for UA

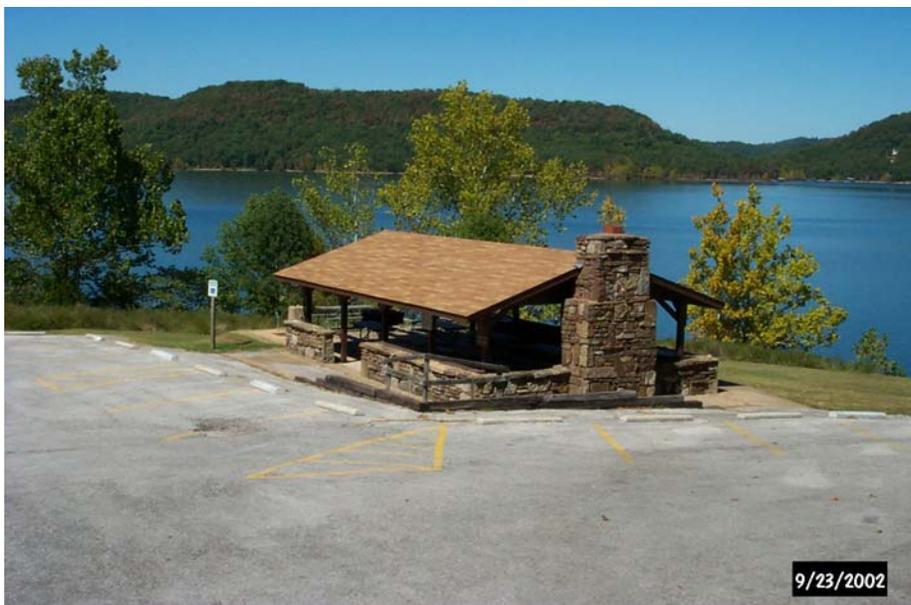
Photo P-4. Picnic shelter parking. Starkey Park, Beaver Lake, AR. This shelter has convenient parking that accommodates UA and loading and unloading of supplies. Also note placement with a scenic lake view (Table 3.2)

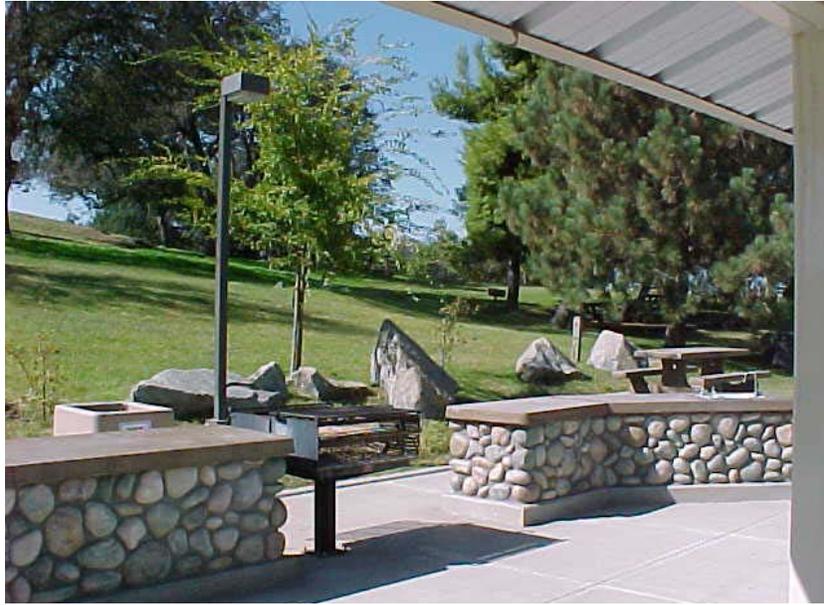
Photo P-5. Picnic shelter features, View 1. Millerton State Park, CA. Concrete pad extends beyond shelter for UA. All surfaces designed for pressure washing. Group size grill, long utility table with GFCI outlets, and nightlight provided. French drain included (visible adjacent to grill) (Table 3.2)

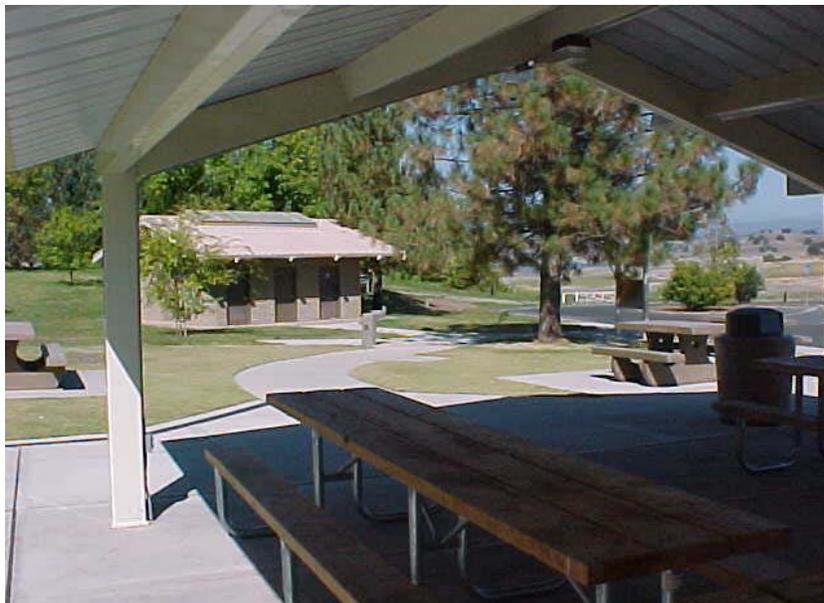
Photo P-6. Picnic shelter features, View 2. Millerton State Park, CA. Shelter is UA. Convenient to restrooms, water fountain, trash receptacle, and GFCI outlet visible on post (Table 3.2)

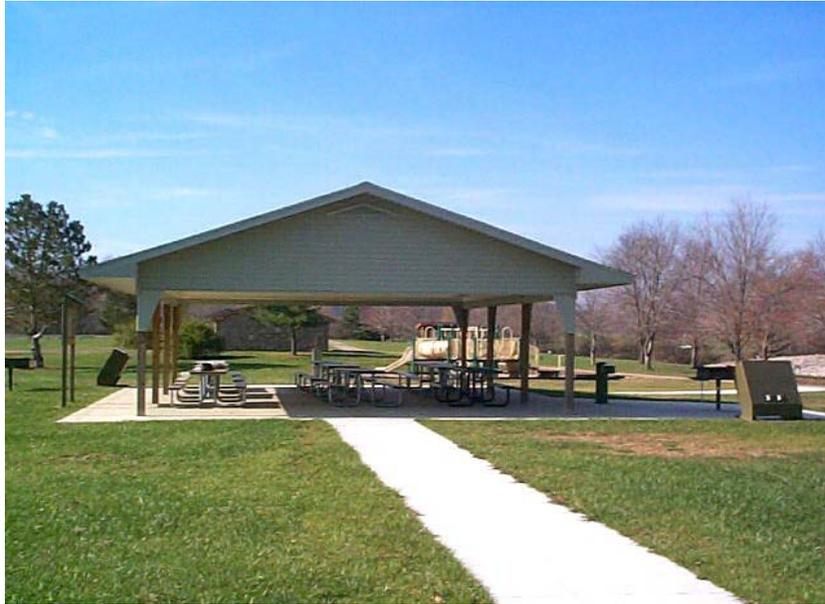
Photo P-7. Picnic shelter features and amenities, View 1. Cave Run Lake, KY. Shelter is UA, has concrete apron, and is convenient to restroom and playground equipment (Table 3.2)

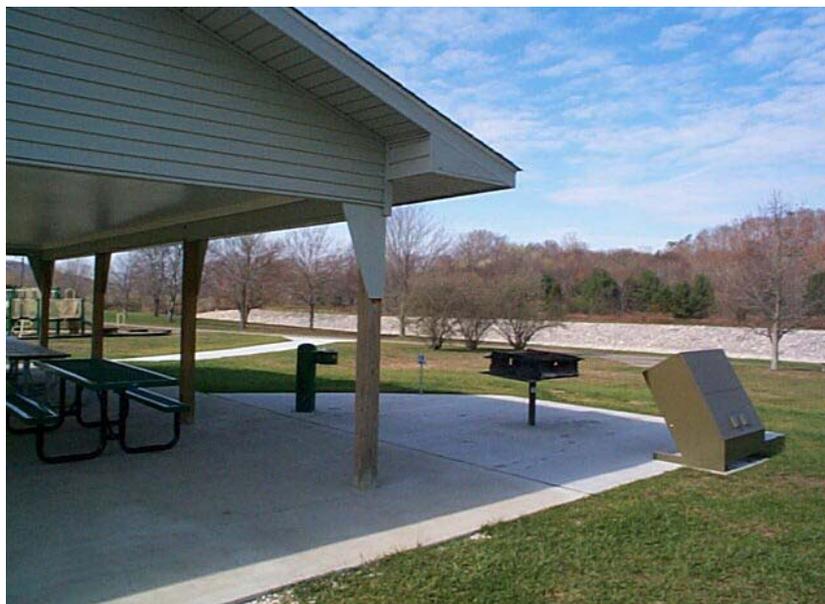
Photo P-8. Picnic shelter features and amenities, View 2. Cave Run Lake, KY. Shelter has low-maintenance vinyl siding at gable ends. Extended concrete apron accommodates UA grill, UA drinking fountain, and garbage containers with UA (side opening) doors (Table 3.2)

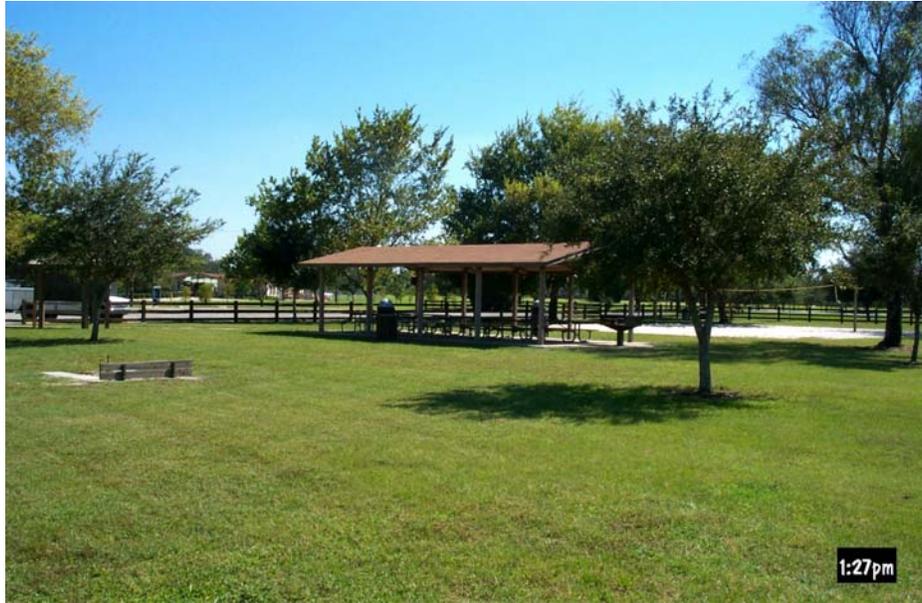
Photo P-9. Picnic shelter amenities. W.P. Franklin South Recreation Area, Okeechobee Waterway, FL. This shelter area offers optional amenities of horseshoe pits (foreground) and a volleyball court (background) (Tables 3.2 and 5.13)

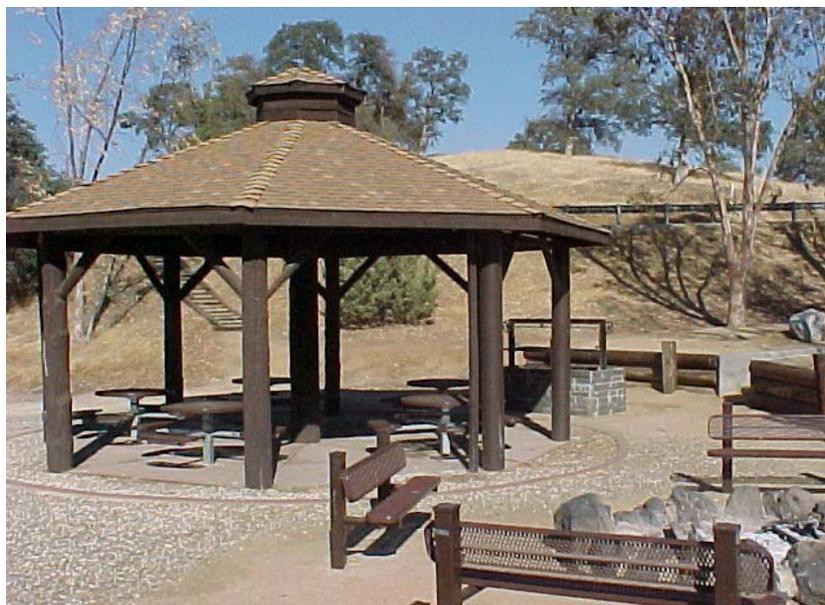
Photo P-10. Small shelter. Hensley Lake, CA. Shelter offers four tables, is totally UA, includes group fire area and benches, and group size grill (Table 3.2)

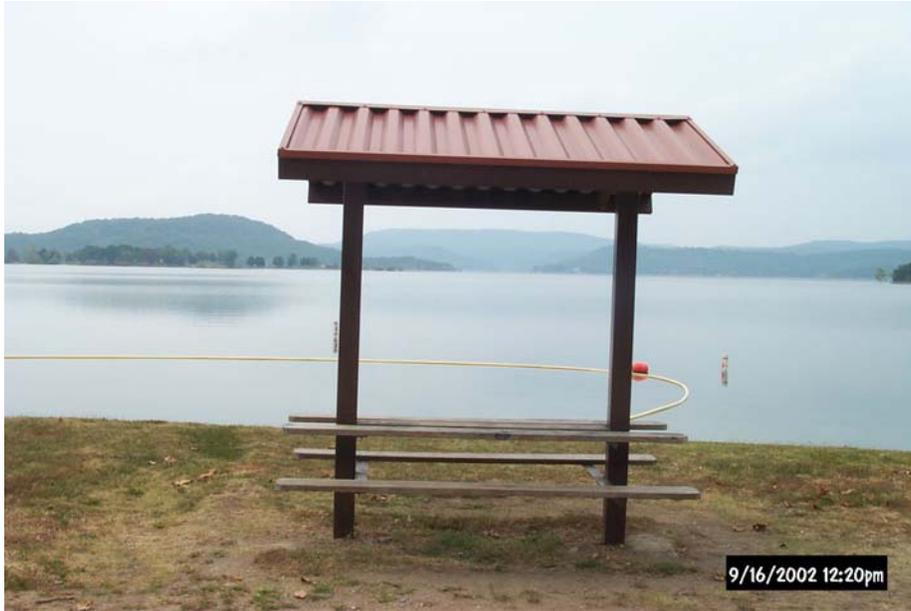
Photo P-11. Covered table. Starkey Park, Beaver Lake, AR. Shade structure constructed to provide shade for table (Table 5.13). Located in conjunction with other amenities, and in this case offers shaded seating that encourages adult supervision of swimming area (Table 5.12)

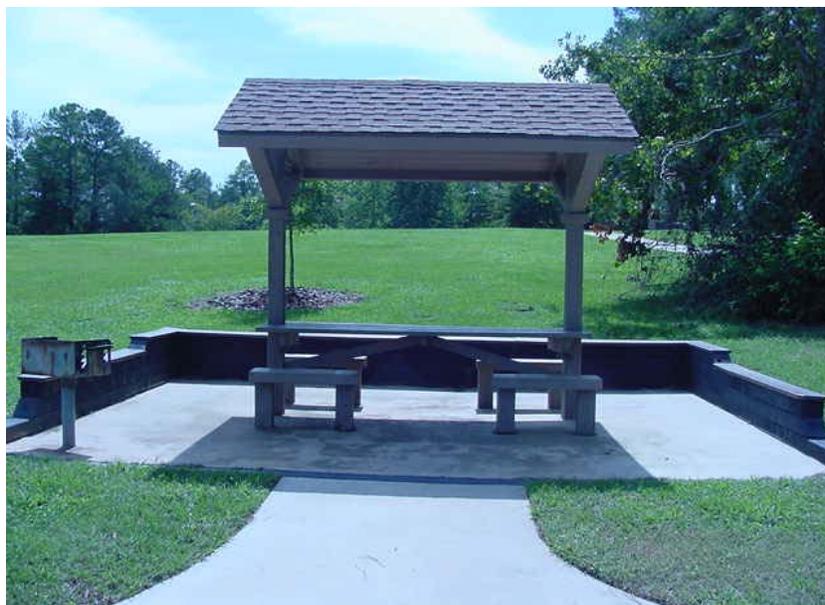
Photo P-12. UA covered table. West Dam Day Use Area, J. Strom Thurmond Lake, GA. Shade structure constructed to provide shade for table (Table 5.13). Note UA features: concrete walk and pad, and split bench design that allows wheelchairs or strollers to pull up to the table (Para. 5.2.1)

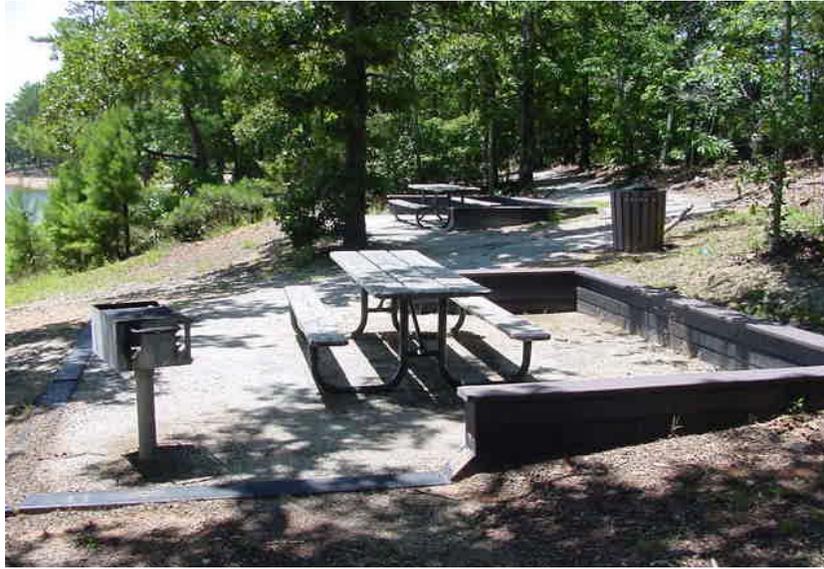
Photo P-13. Single picnic site. Lake Springs Day Use Area, J. Strom Thurmond Lake, GA. Table located on delineated impact pad (Table 4.1), includes shade, pedestal grill, and scenic view (Tables 5.13 and 5.14)

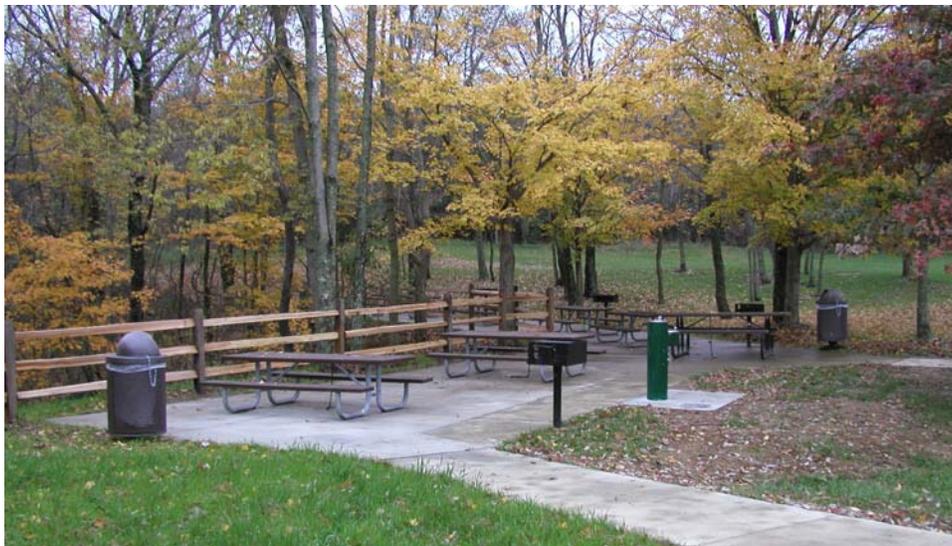
Photo P-14. Multi-table site. Overlook Area, Taylorsville Lake, KY. In addition to individual sites, groupings of picnic tables are recommended to accommodate customer demand. Note that water fountain, pedestal grills, garbage cans, and hardened surface are provided (Table 5.13)
